ENVIRONMENTAL ASSESSMENT

*NORTH NASHUA RIVER
CHANNEL IMPROVEMENT*

**FITCHBURG LOCAL PROTECTION
FITCHBURG, MASSACHUSETTS**

NOVEMBER 1977

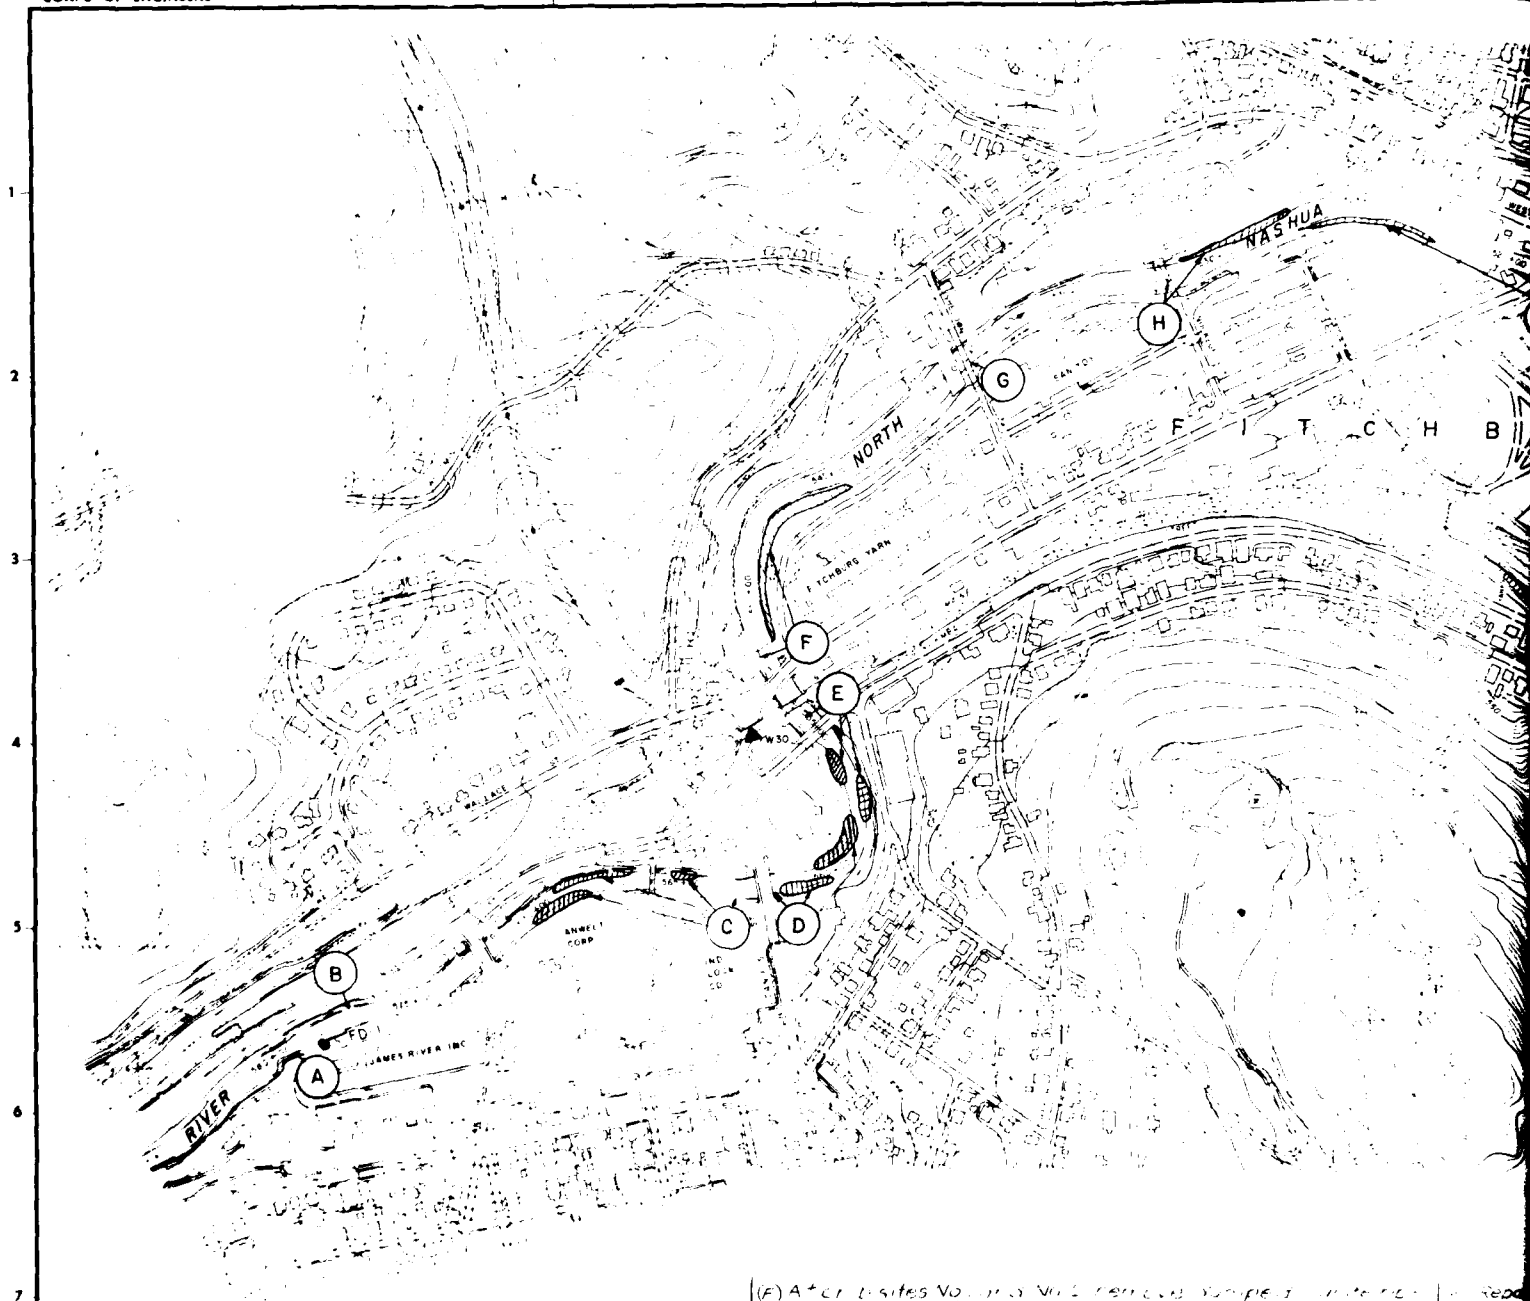
PLATE I

1. Remove random boulders from the
stream.

Repair localized erosion downstream of bridge on
roadment and remove debris from the ditch immediately
down stream from bridge and structure.

(F) After isolates Vol. 1 and Vol. 2 removed samples of the top 100 mm of both banks for 30m + 105 feet of the channel. Remove and determine the rate. 20 ft. length of the dumped granite replace right bank with concrete wall and lining and use bank liner on left side. remove material to fill. Remove selectively and reposition the large boulders in the channel. Shading is to be used.

Repair downstream on pile with least major strengthening.
Also repair gouted pile cap on river bottom and well around pile
cap is to be placed downstream to prevent further pile well cap

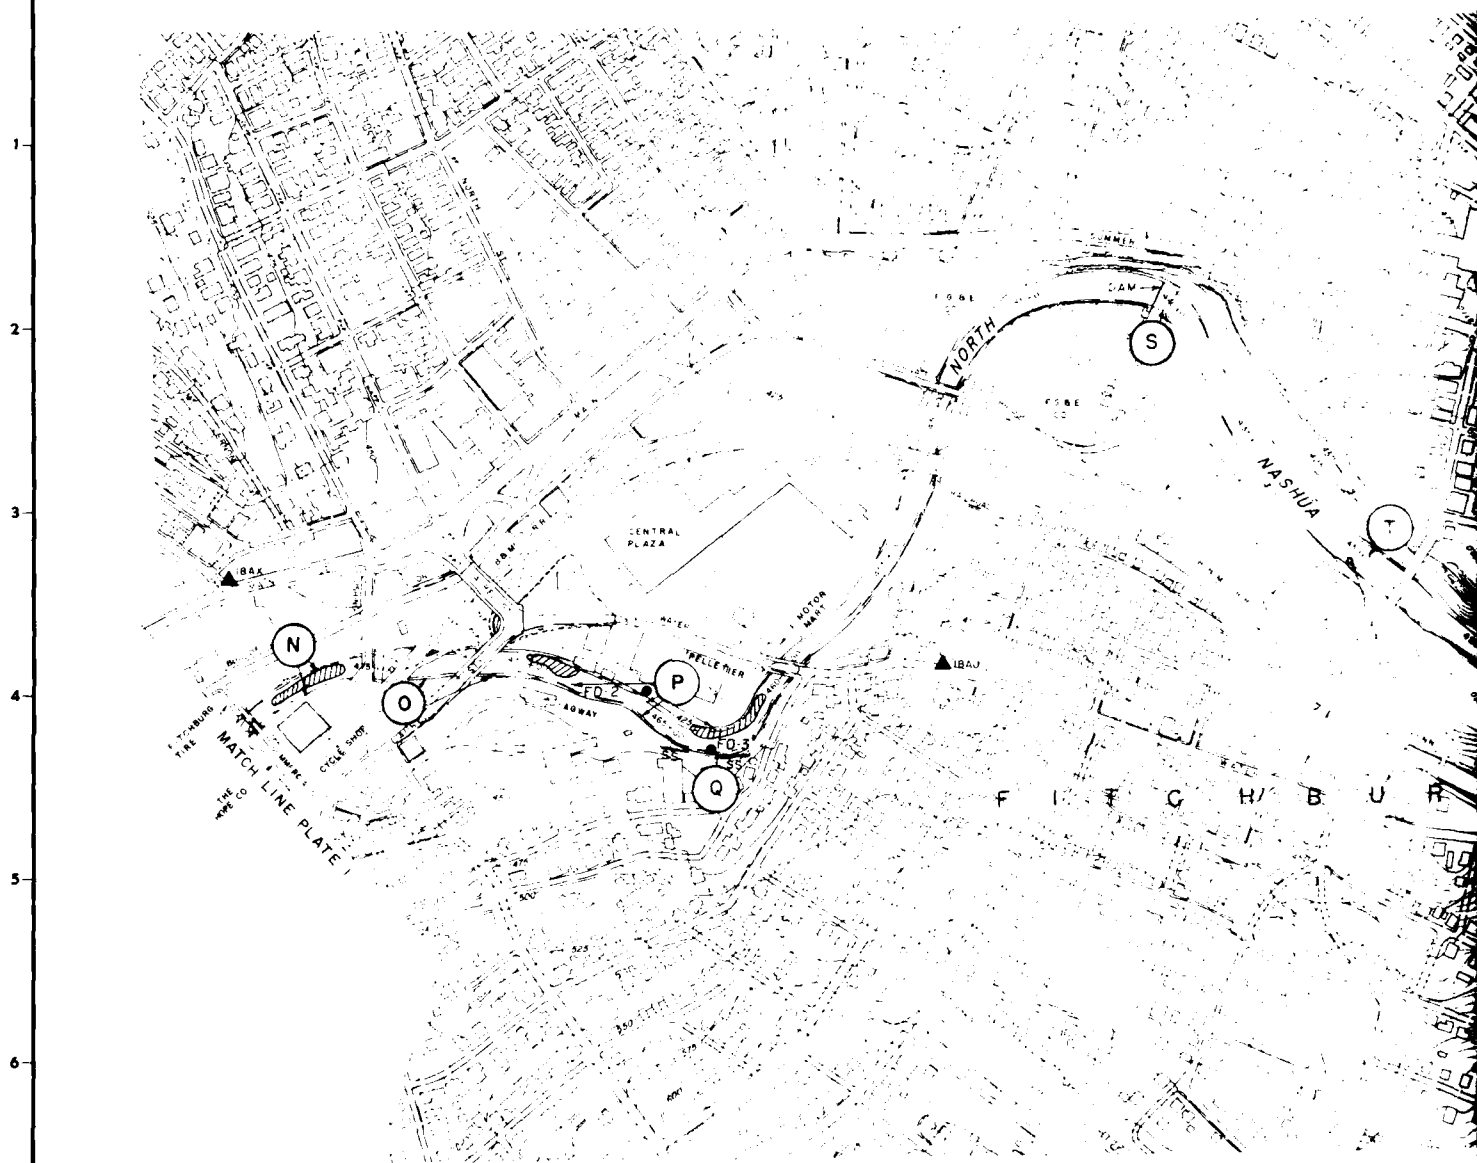
(1) Build concrete wall on left bank so that its top elevation will be the same as the top elevations along left bank wall. Remove shoring.

(2) Remove about 10 feet of concrete abutting at right angles No 5 and No 6 and replace with concrete wall.

o. At Laurel Street along the right bank above the streambed and adjacent to railroad siding, remove about 250 feet of deteriorated concrete cribbing (Crib Site Nos. 5 and 6) and replace with concrete wall, three sections.

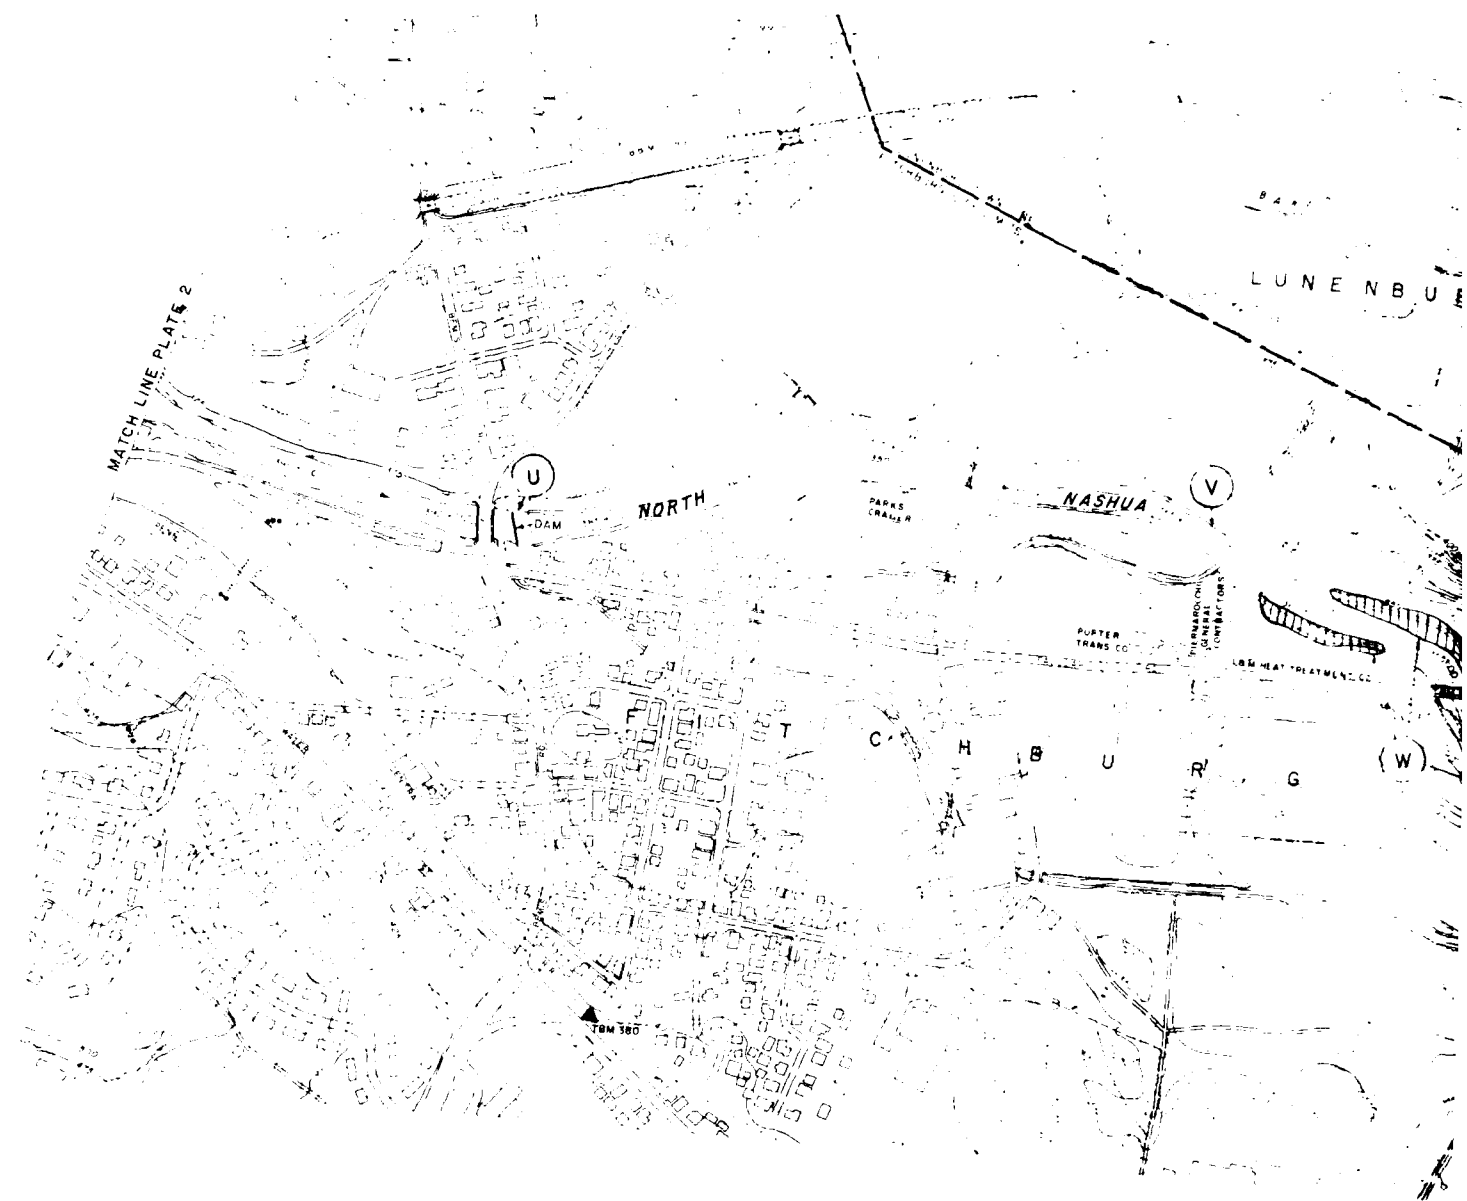
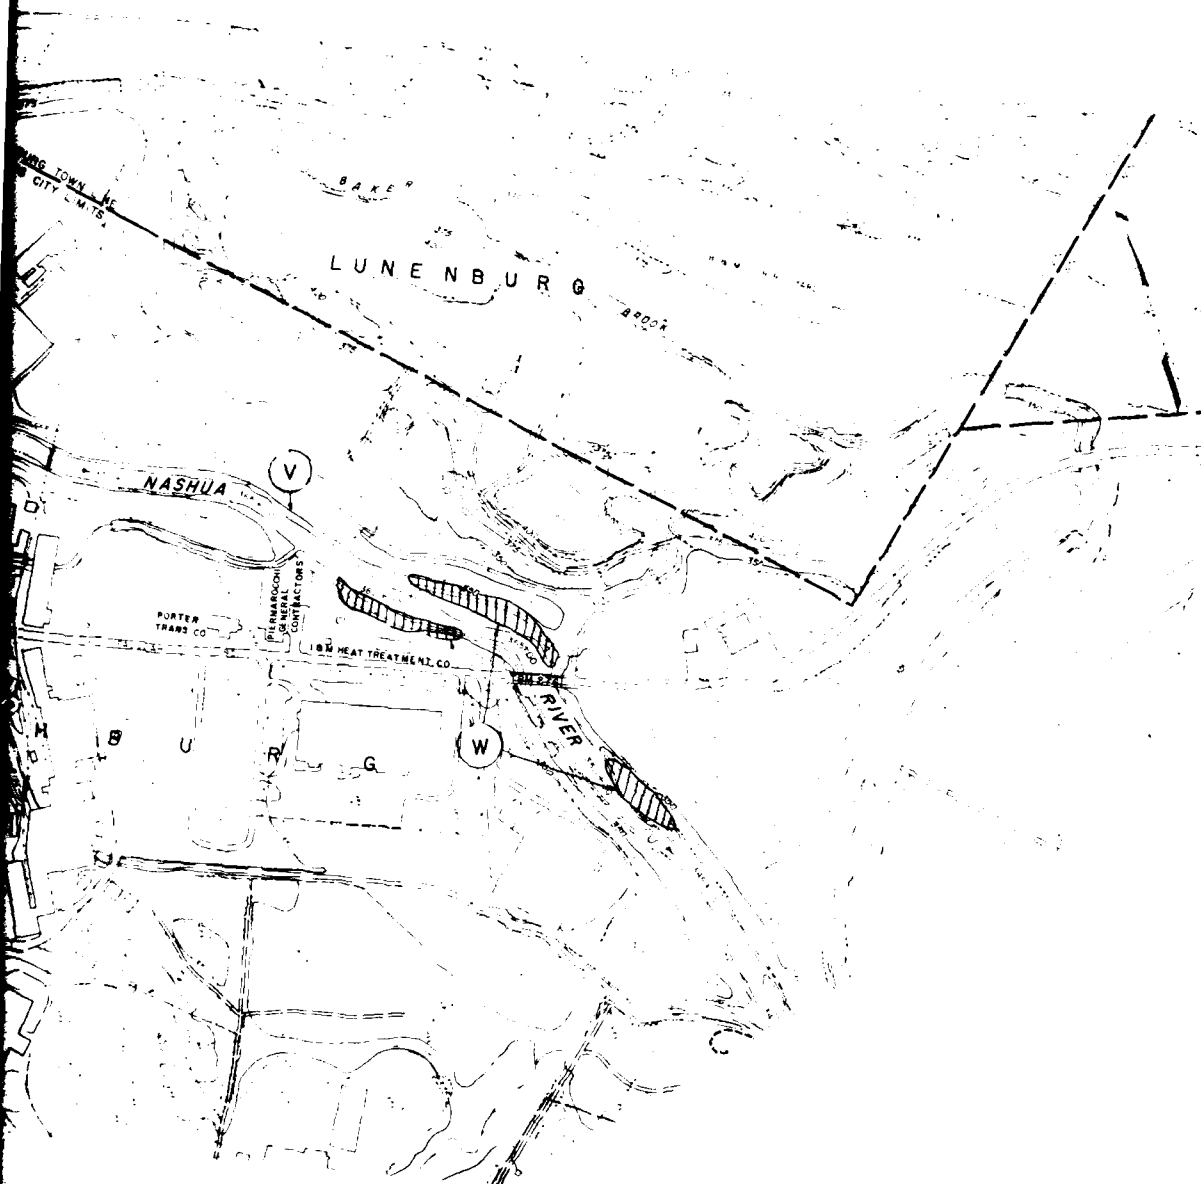
KEY

- (U) Reset large broken stones in stream immediately down stream from Bemis Road dam.
- (V) Restore and prevent further erosion of banks and river bottom regrade and place riprap protection on the adjacent river bank and restore the outlet of the canal into the river.
- (W) Remove shoaling.

u. Reset large broken stones in stream immediately downstream from Bemis Road dam.
